# Inadvertently Lost Cannula Sheath in External Jugular Vein: A Rare Incident

## ABSTRACT

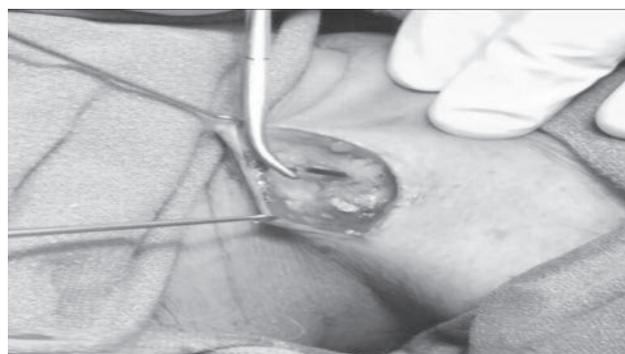
After discussion, it was decided to explore under general anesthesia. Patient was taken to the operation theater and after giving general anesthesia, part was painted and draped, transverse neck skin incision was given, flaps raised and the right EJV located (Fig. 1).

**Figure 1.** Cannula sheath within the right EJV seen at exploration.

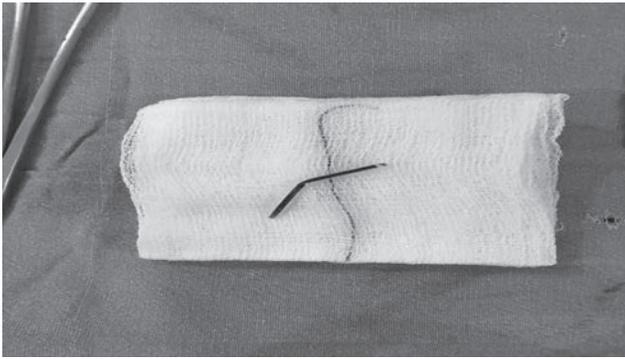
had fractured at the junction with the port site and complete sheath of the cannula had got lost in EJV.

Ultrasound on the local area was done and that revealed a well-defined linear artefact with parallel echogenic lines, of approximate size 3.9 cm, in distal part of right EJV with thrombus in the surrounding region, upper part of the right EJV was normal. This was suggestive of broken catheter with thrombus in EJV.

Figure 2. Extracted cannula sheath.

Phlebotomy done and cannula sheath removed safely (Fig. 2). Complete hemostasis was achieved and skin was closed with staplers. Patient was then inserted central venous line in left subclavian vein. She was managed in ITU for another 4 days and after complete resolution of pancreatitis, she was shifted to general ward and discharged from there after 2 days.
